CALSPAN ON-SITE AIR BAG DEPLOYMENT INVESTIGATION

CALSPAN CASE NO. CA96-07

**VEHICLE #1 - 1996 FORD CONTOUR GL (AIR BAG EQUIPPED)
VEHICLE #2 - 1983 LINCOLN CONTINENTAL MARK VI**

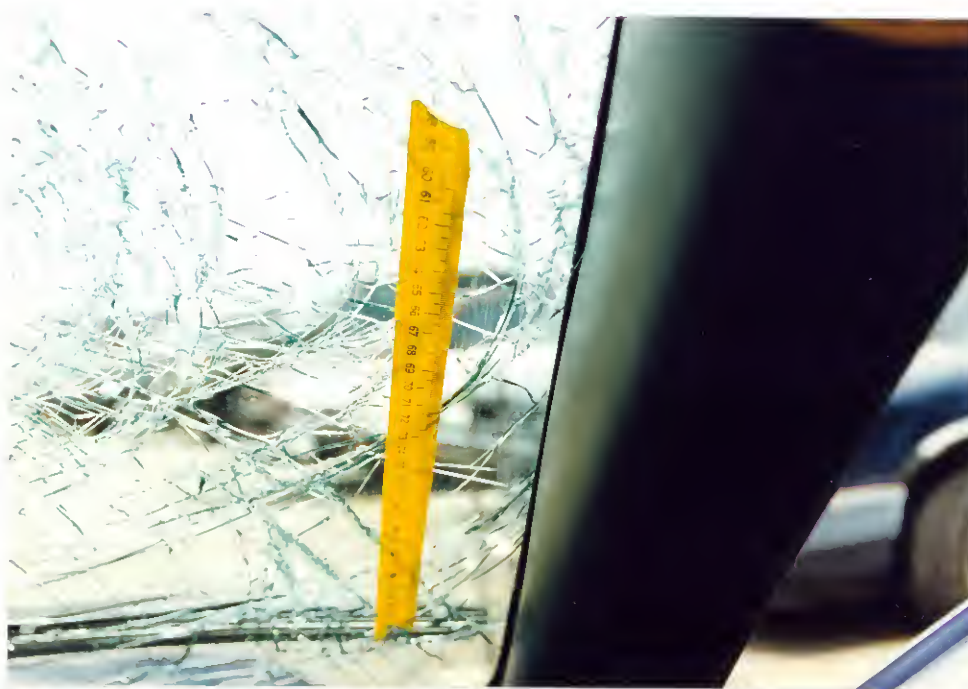
44. View of a whitish color transfer mark adjacent to the right upper A-pillar.

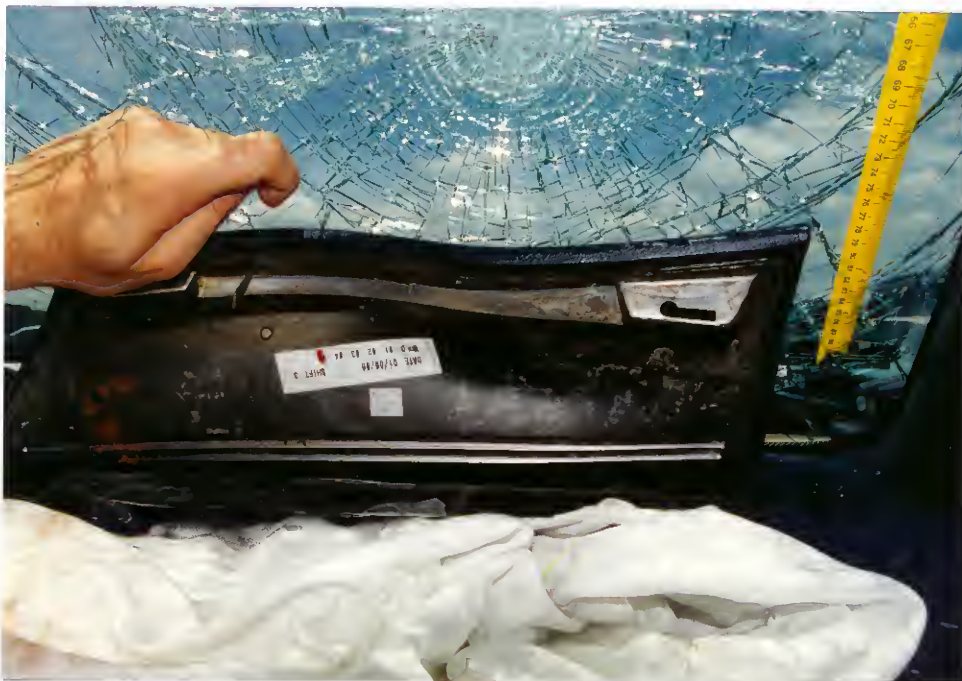
48. View of the underside of the right front passenger air bag cover.

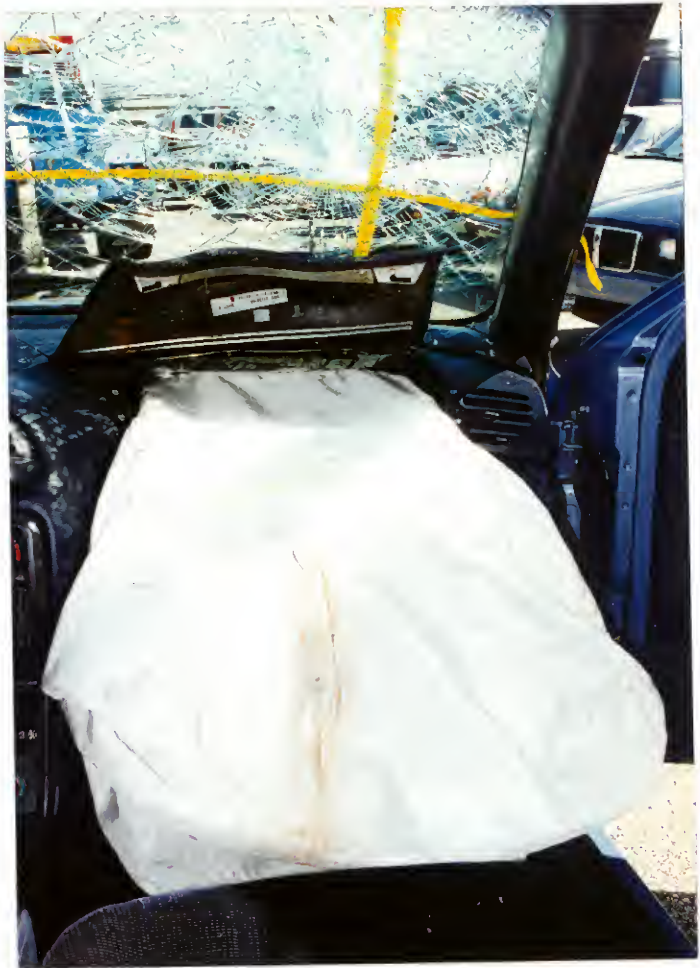
50. Closer lateral view of the contact evidence on the surface of the passenger side air bag fabric.

The passenger side air bag exhibited striated bodily fluid transfers located in the center of the air bag which measured 49.5 cm (19.5") vertically. These were the result of contact with the right front occupant's neck and spinal column. Black fabric transfers attributed to contact with the boy's jacket were also observed in the vicinity of these transfers.

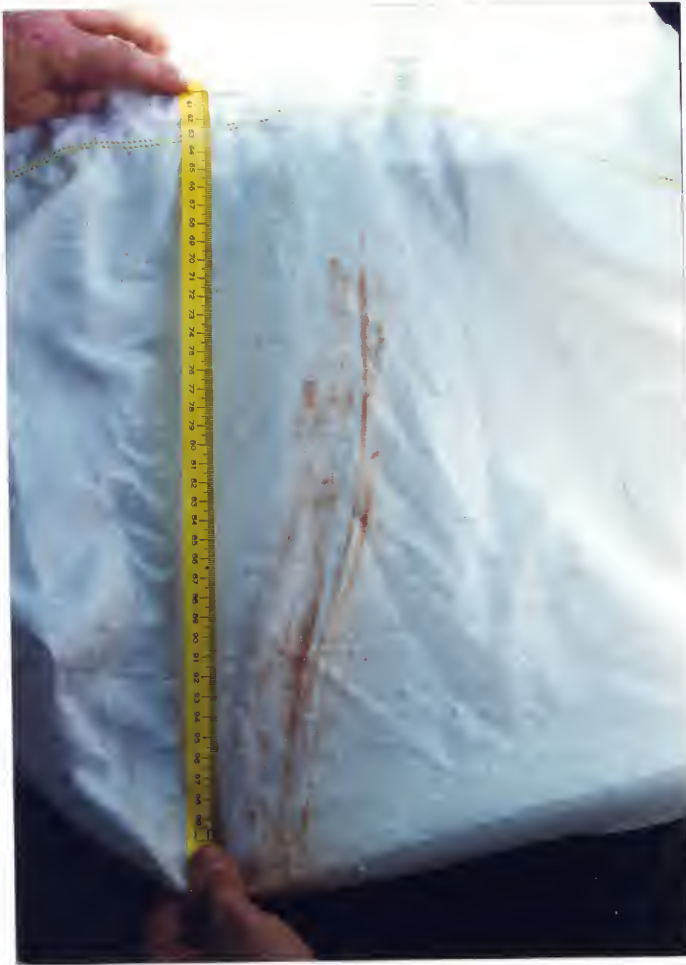
51., 52. Close-up views of the contact evidence on the surface of the air bag. The contact evidence include bodily fluids, tissue transfer, and clothing fabric.

The passenger side air bag exhibited striated bodily fluid transfers located in the center of the air bag which measured 49.5 cm (19.5") vertically. These were the result of contact between the expanding air bag and the right front occupant's neck. Black fabric transfers attributed to contact with the boy's jacket were also observed in the vicinity of these transfers. There were two bodily fluid deposits noted at the bottom of the passenger air bag which were in-line with the striated bodily fluid transfer marks.

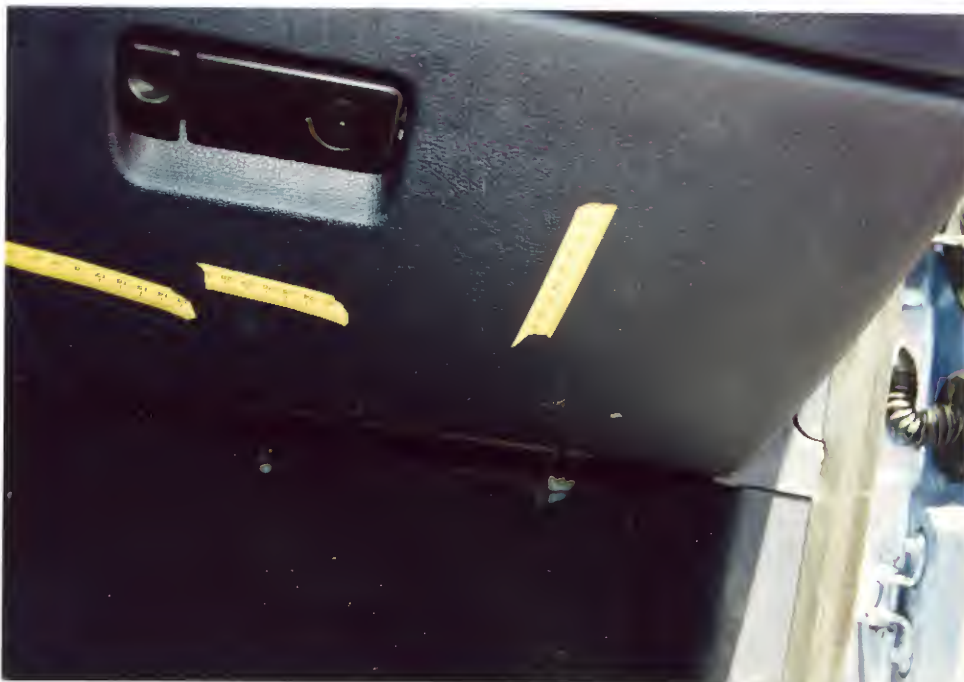
54. Contact evidence on the glove compartment door.

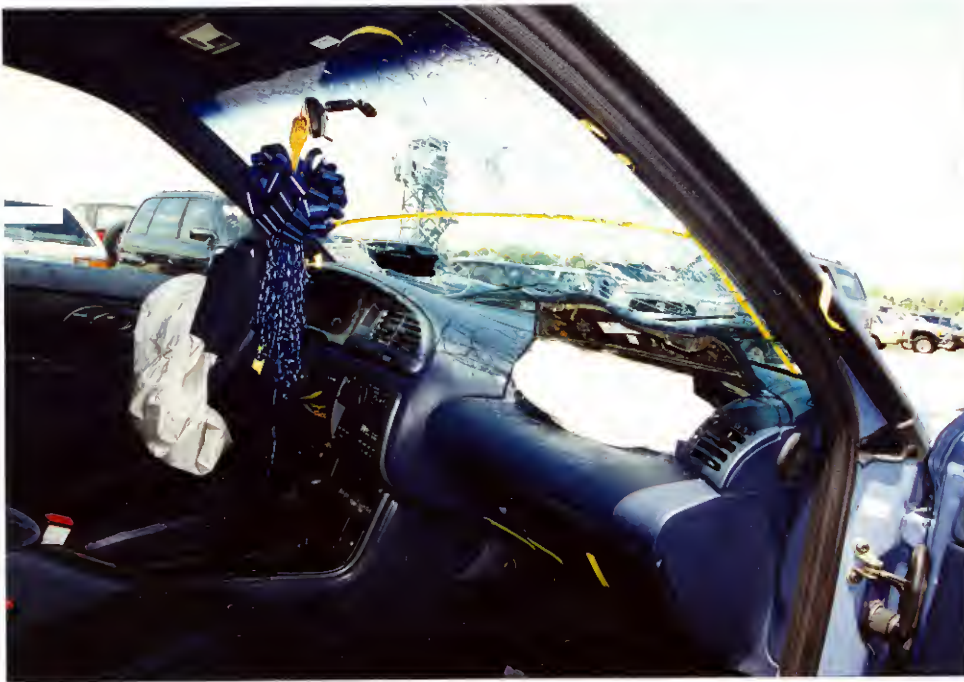
55., 56. Angular views of the instrument panel showing the passenger side air bag module cover in two different positions.

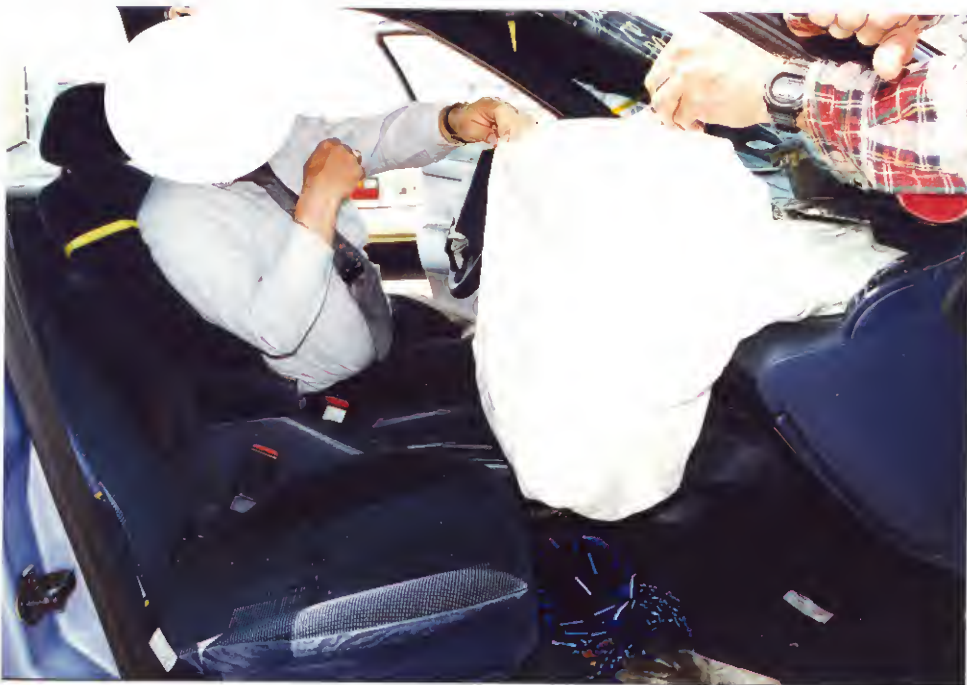
57., 58. Additional views of the passenger side air bag. The second view was manually stretched to its maximum rearward extension.

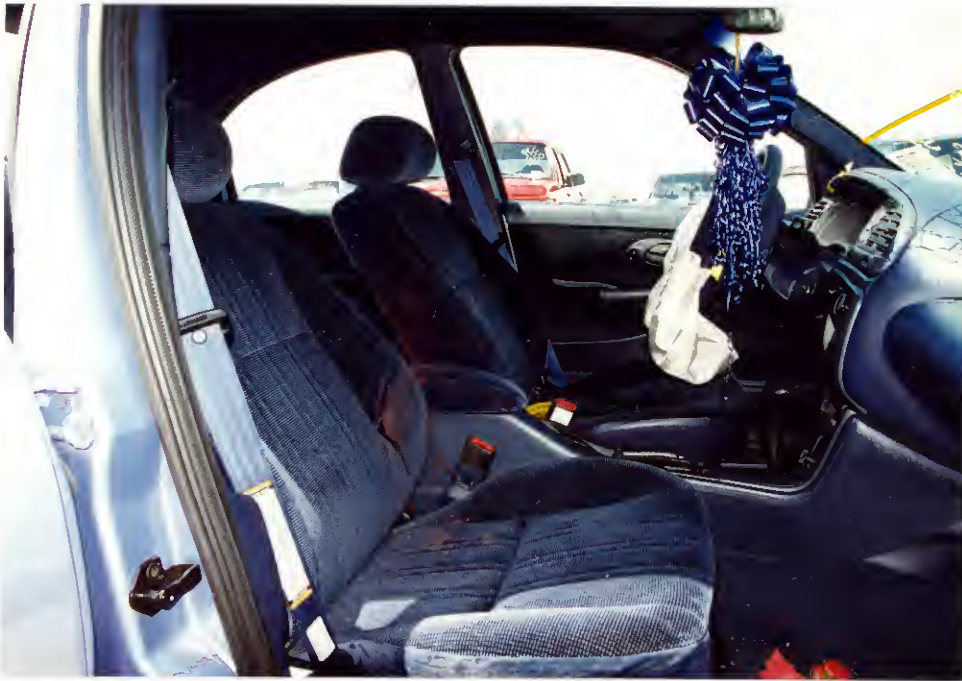
59. Lateral view of the front seats highlighting the bodily fluid transfers on the seats and center console.

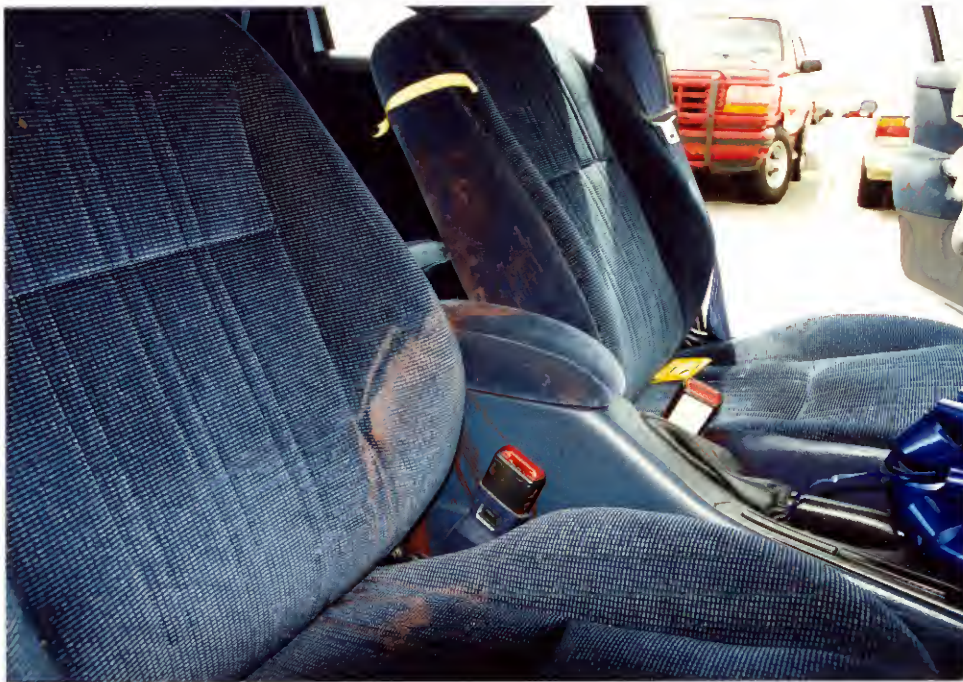
60. Closer view of the bodily fluid transfer on the seat back rests, center console, and right front seat belt buckle.

The interaction of the air bag on the boy's chest and the entrapment of his neck by the air bag module cover leveraged his head from his torso resulting in a near decapitation type injury. His head then moved rearward and struck the windshield header which was noted by strands of black hair embedded in the fabric overlaying the windshield header. He came to rest between the front bucket seats with his head on floor behind the center console, his buttocks on the console surface with his chest facing upward. A heavy concentration of bodily fluid deposited on the center console substantiated this final rest position.

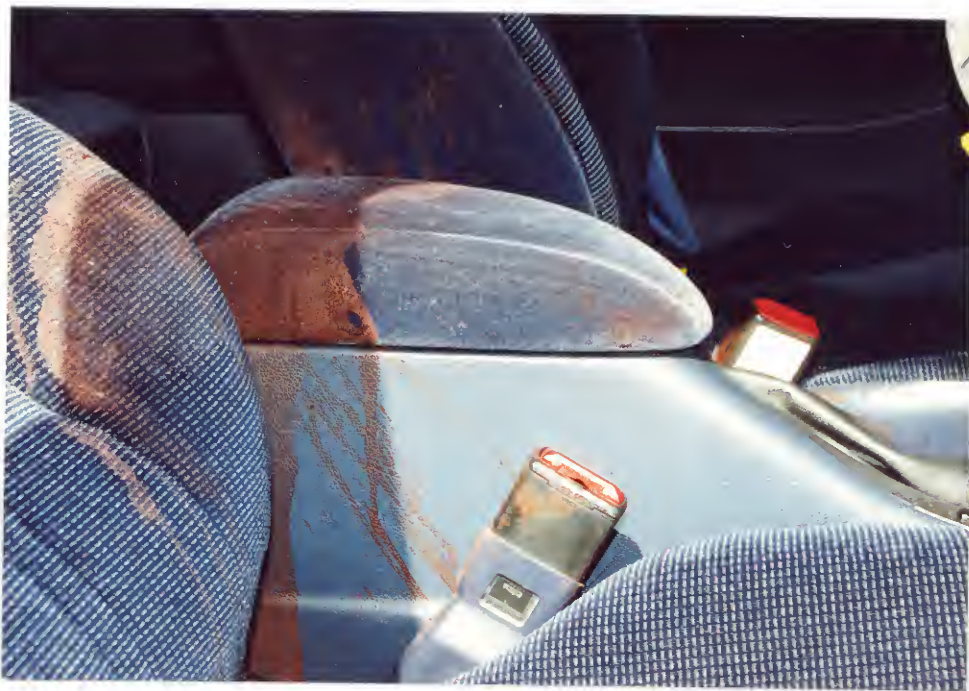
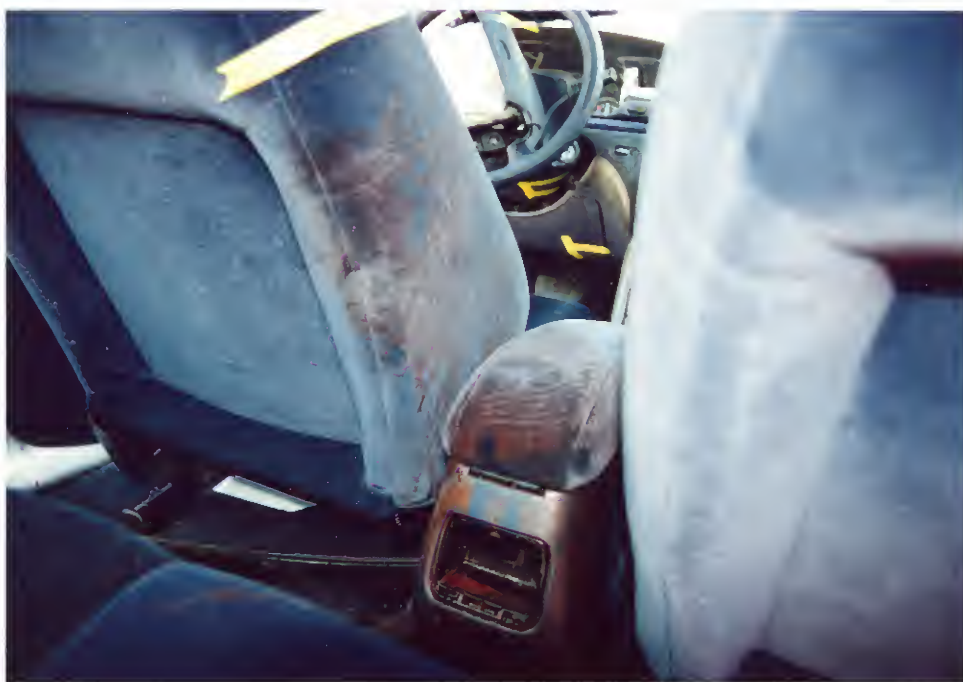
61., 62. Close-up views of the bodily fluid transfers.

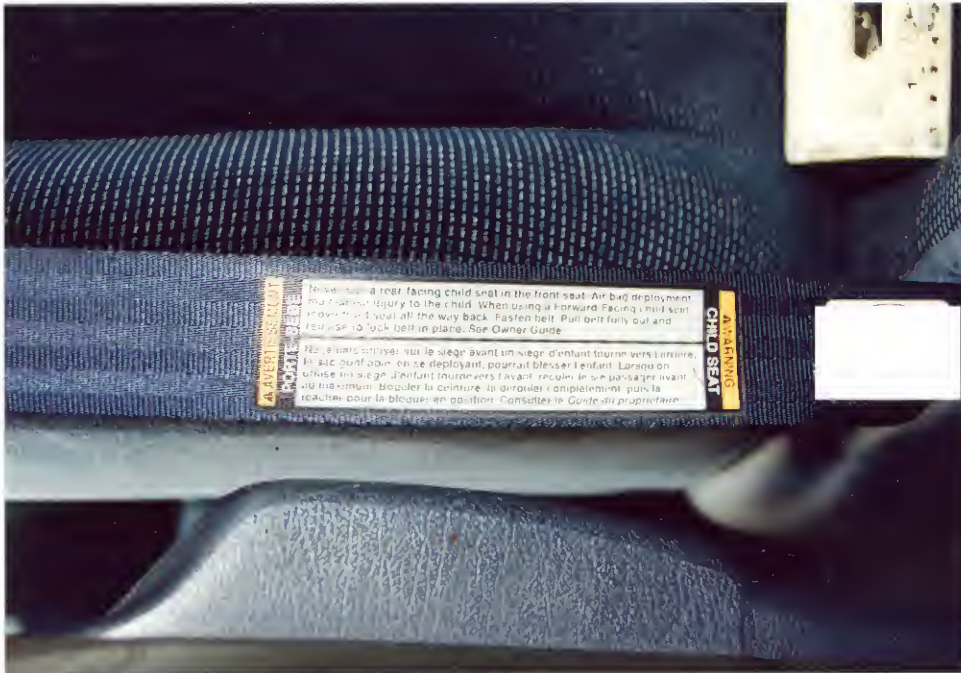
- For maximum safety protection in all types of crashes, you must always wear your safety belts.
- Do not install rearward-facing child seats in any front passenger seat position.
- Do not sit or lean unnecessarily close to the air bag.
- Do not place any objects over the air bag or between the air bag and yourself.

63. View of the air bag warning label on the right front seat belt.

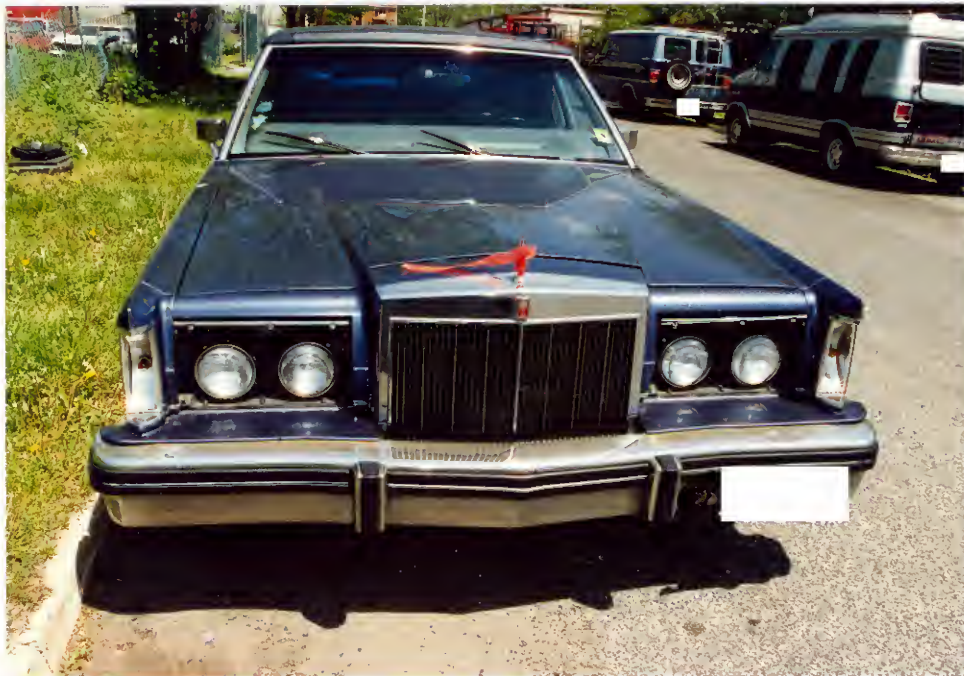
65. Frontal view of the 1983 Lincoln Continental Mark VI (Vehicle #2) showing impact damage.

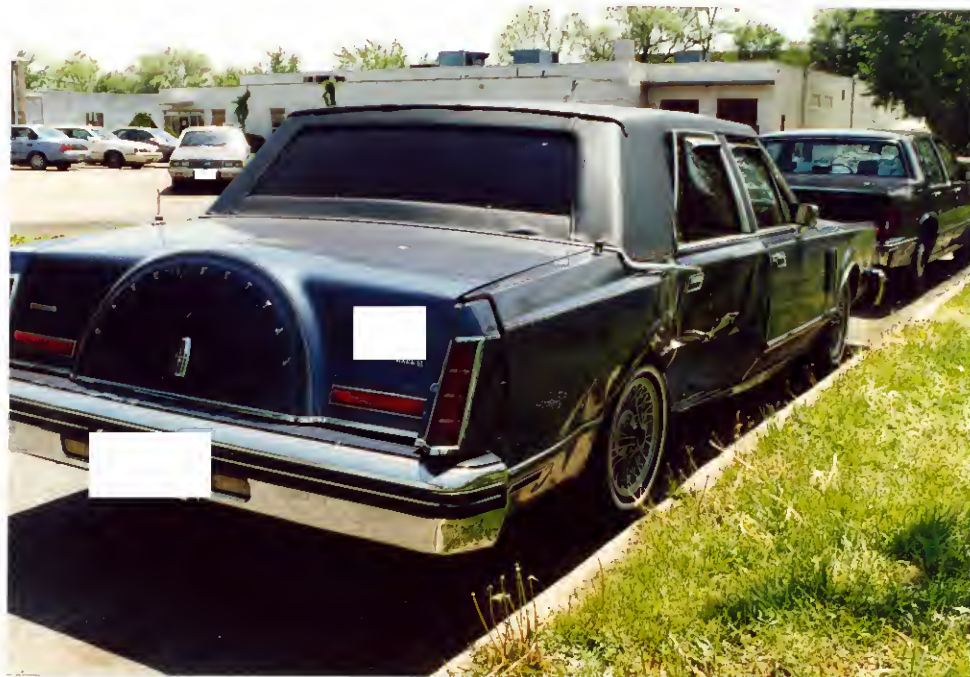
68. View of the right rear corner.

Components damaged in the crash included the rear bumper, the right rear quarter panel, and the right rear door.

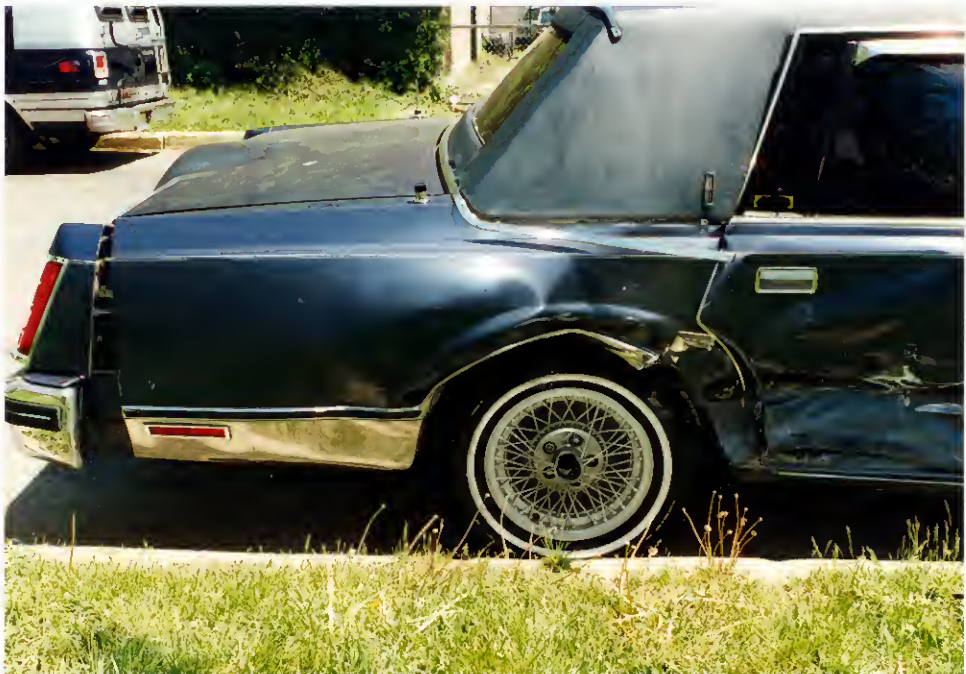
70. View of the direct contact damage on the right side pane.

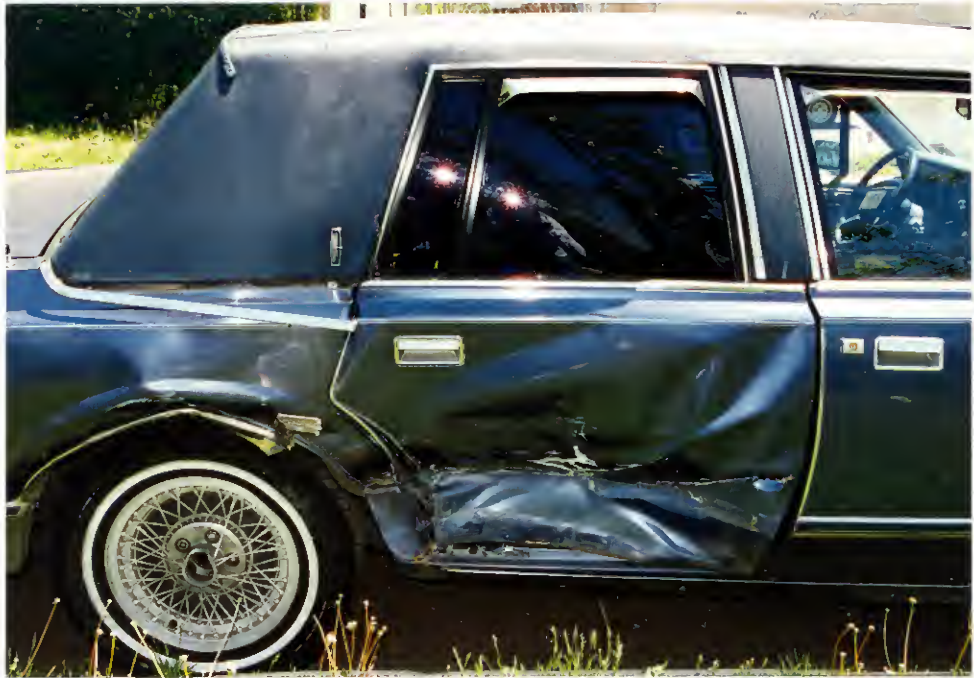
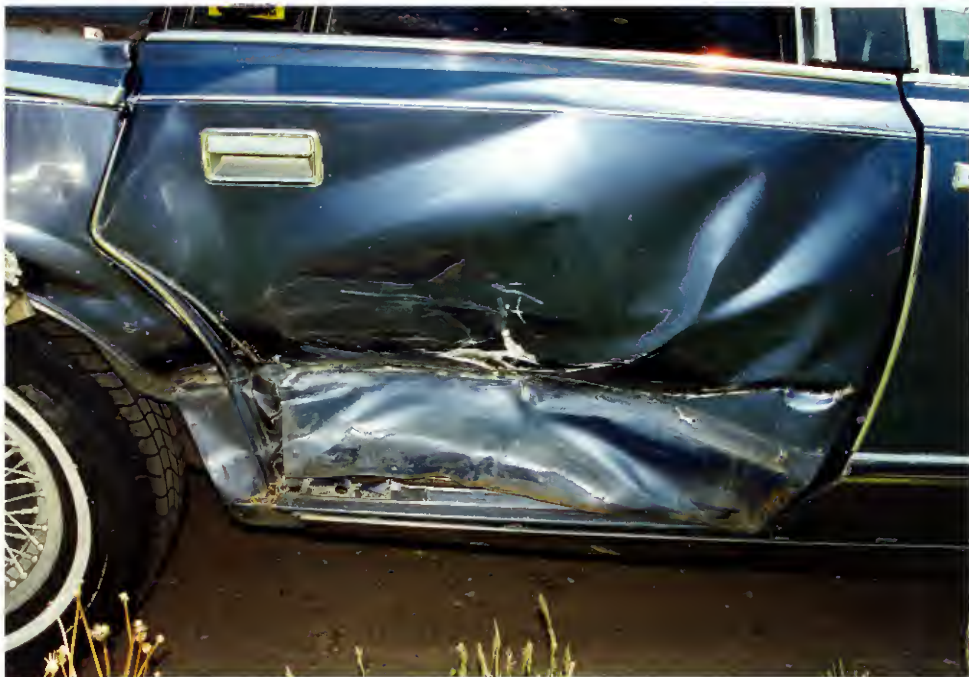
71., 72. Closer views of the maximum crush area.

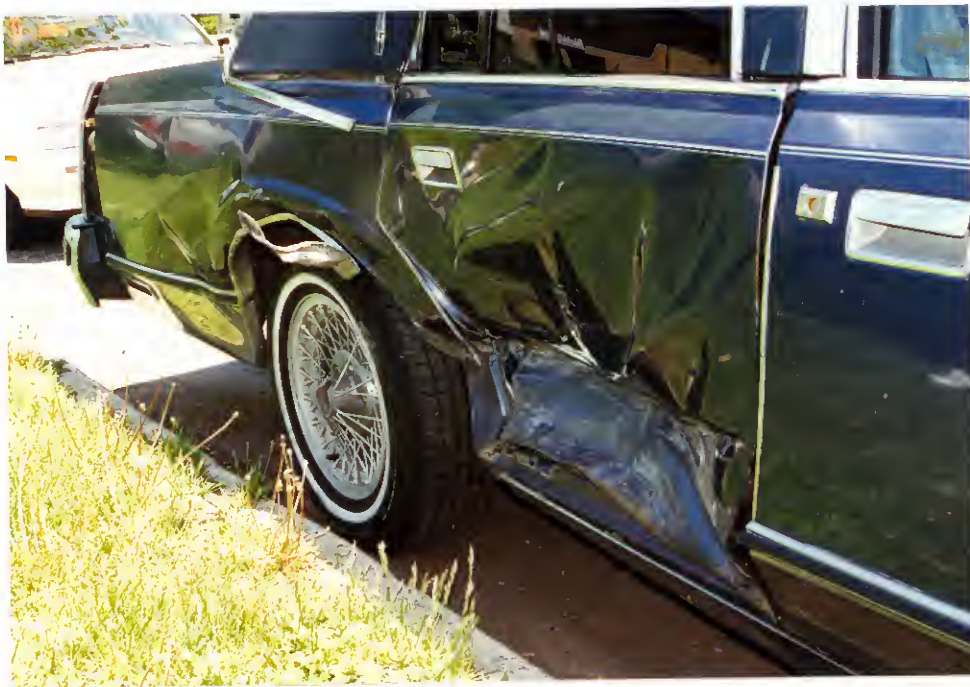
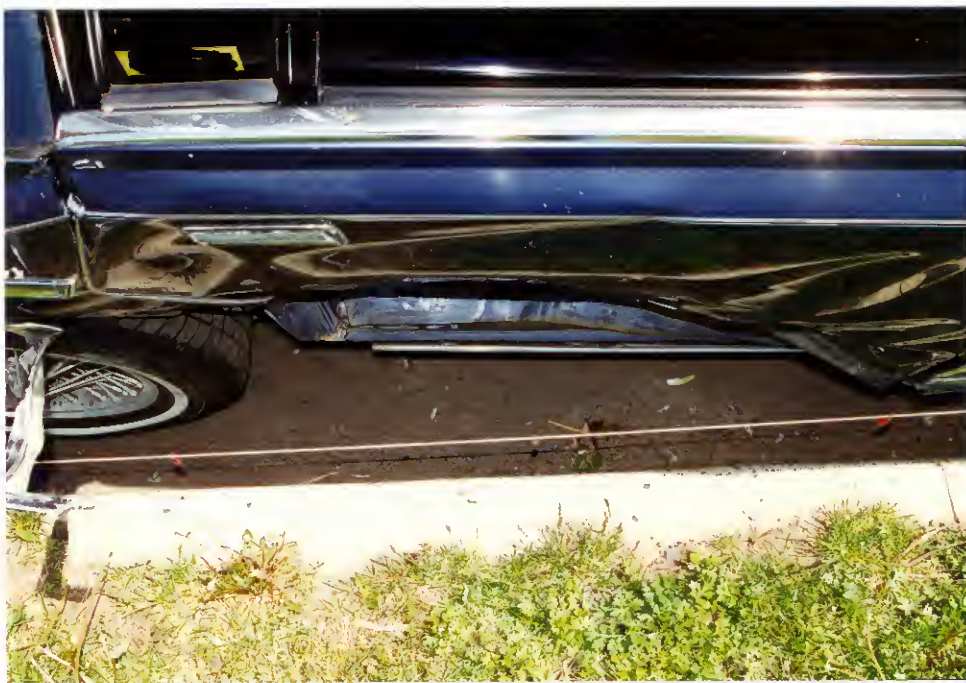
73., 74. Angular and overhead views of the direct contact damage.

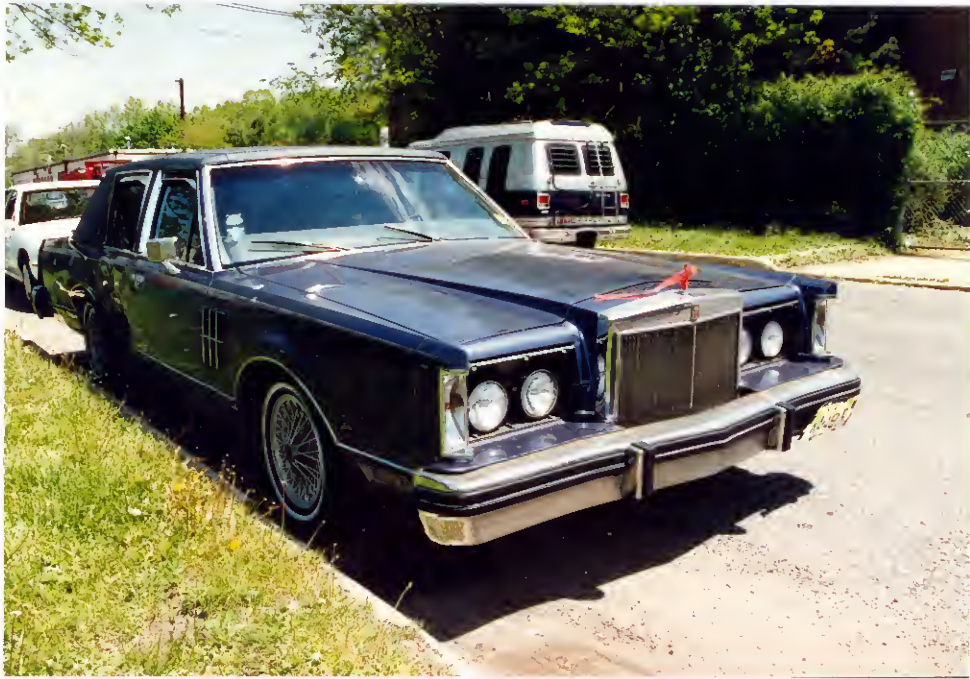
75. View of the right front corner.

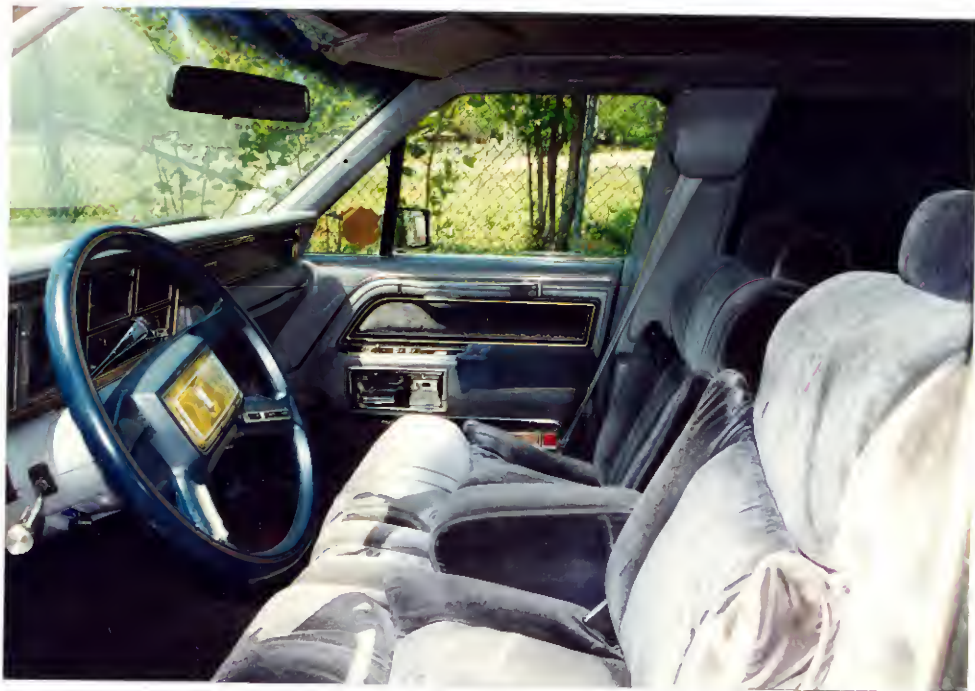
76. Perpendicular view of the right front door surface of Vehicle #2 including a lateral view of the left front seat back rest and instrument panel.

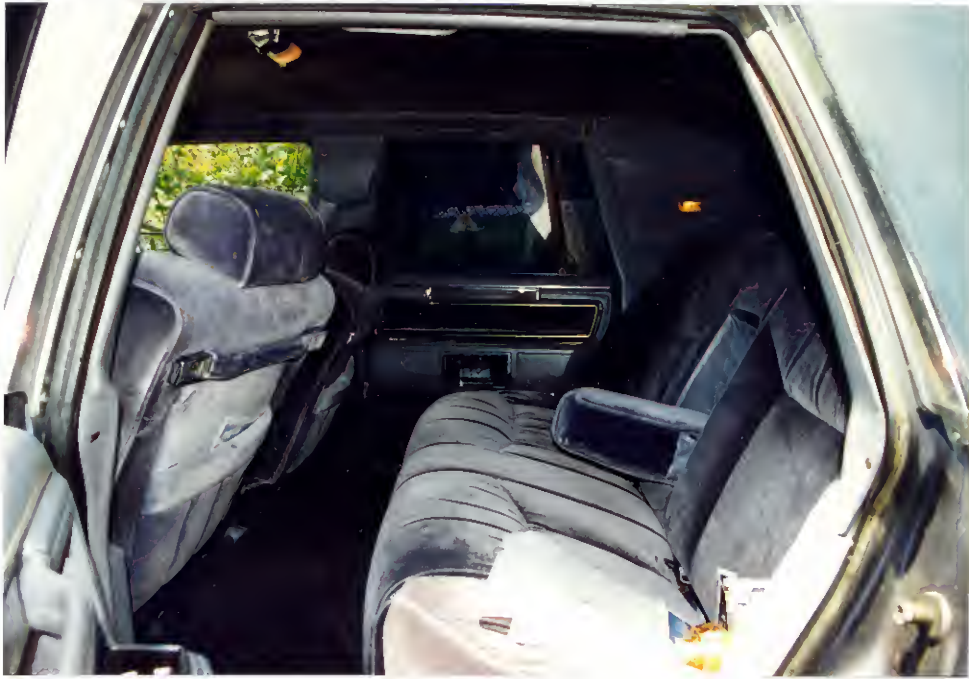
77. View of the rear seat area.

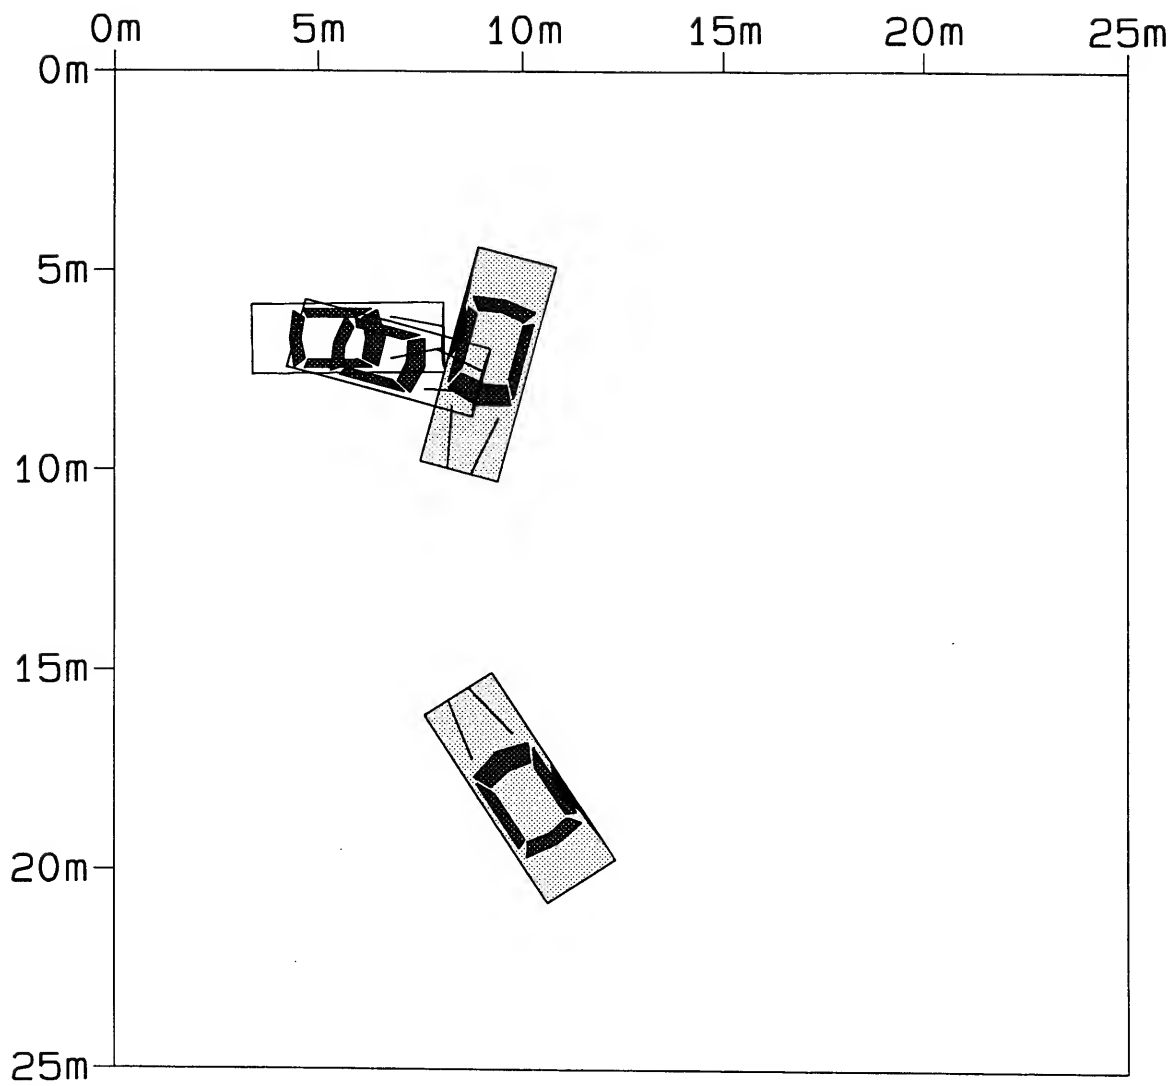
Vehicle #1 áááááááááá	Vehicle #2 áááááááááá
Year	1995	1983
Make	Ford	Lincoln
Model	Contour	Mark VI
CDC	11FDEW1	02RZEW3
Side Damaged	F	R
PDOF Angle	-19 ½	55 ½
Heading Angle	359 ½	105 ½
